Manhole Inspection Summary

Manhole # S31EE_003MH

Insp Date: **1/25/07 10:14 AM**

Location Address: **29TH DIVISION ST**

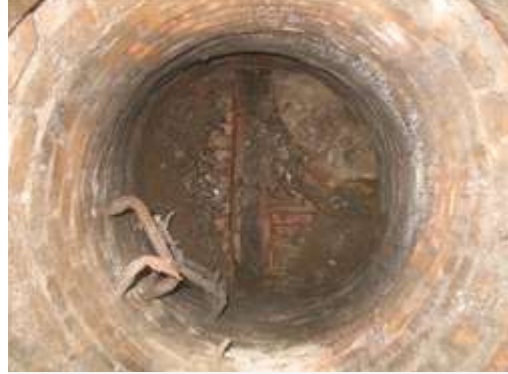
Top View

Corroded and missing steps. Evidence of surcharge - Bench debris. Channel debris.

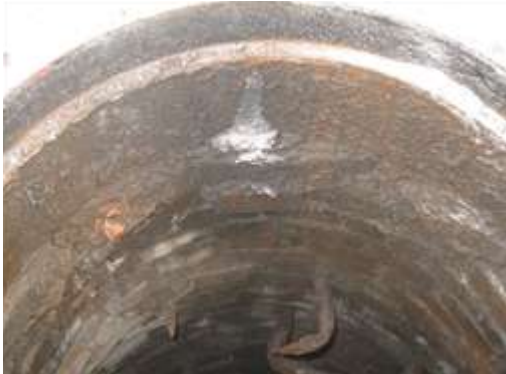
Defect

Frame leaks. Adjustment deterioration and infiltration. Corbel infiltration.

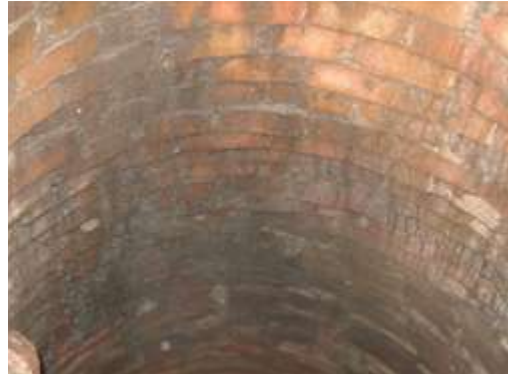
Defect

Adjustment, Corbel and Barrel infiltration.

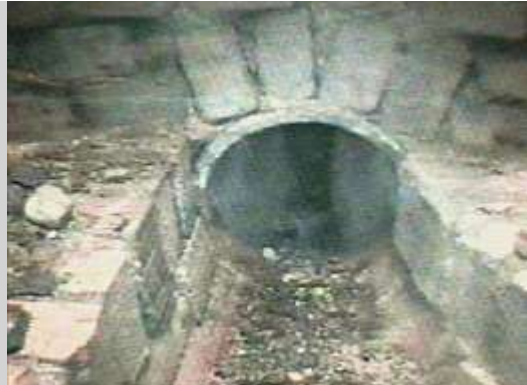
8 in. Circular Gravity Sewer Pipe Out @ 12 O'Clock

Deposits: ☐ None ☒ **Mud** ☐ Sludge ☒ **Debris** ☐ **Grease**

Silt Depth: **0** (in.) Deposits Extent: **Light**

Infiltration: **None** Pipe Seal Cond: **Unknown**

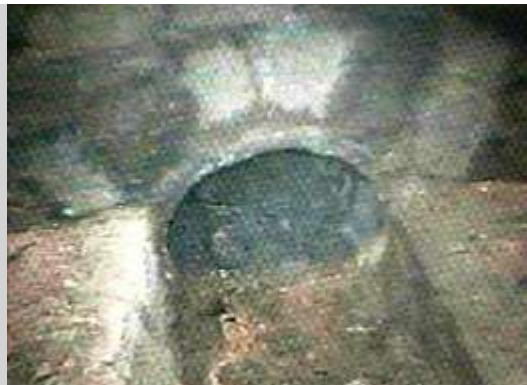
8 in. Circular Gravity Sewer Pipe In @ 3 O'Clock

Deposits: ☐ None ☒ **Mud** ☐ Sludge ☒ **Debris** ☒ **Grease**

Silt Depth: **1** (in.) Deposits Extent: **Light**

Infiltration: **Evidence** Pipe Seal Cond: **Unknown**

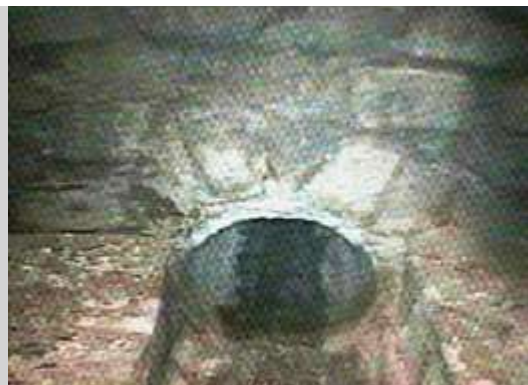
Pipe In @ 6 O'Clock

Deposits: ☐ None ☒ **Mud** ☐ Sludge ☐ Debris ☒ **Grease**

Silt Depth: **0.5** (in.)

Infiltration: **Evidence**
